INDUSTRY CASE STUDY

AmeriSchools Academy—Yuma Carbon Fiber Reinforcement

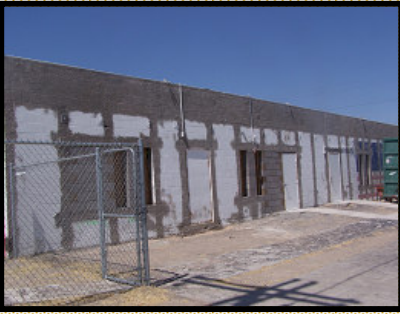
The walls following sandblasting to remove the exterior paint. Fabric would be applied to the wide band at the top of the wall, and horizontal and vertical laminates would be applied around all of the window and door openings.

Carbon-fiber wrap of fabric around the parapet of the building, and laminates spaced vertically every 4'oc on bearing walls, and horizontally above and below all door and window openings, to reinforce the CMU masonry. The roof configuration would not allow solid-grouting of the masonry walls, and so the application of carbon-fiber fabrics and laminates was the least expensive and most efficient means of repair.

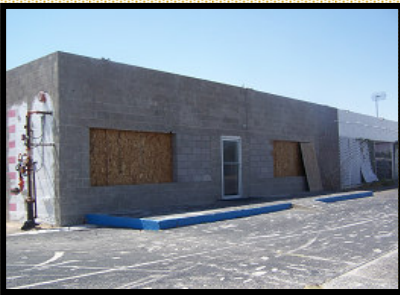
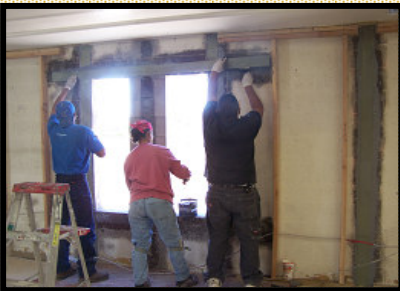
The above picture shows the crew installing carbon-fiber laminates on the interior walls and openings.

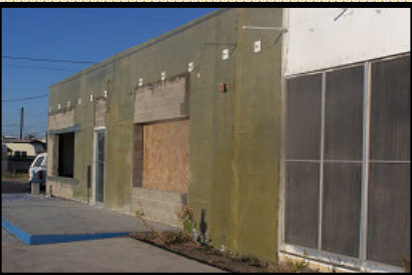
This picture shows the front entry after the application of bi-directional fabrics.
