MASONRY

Arizona Repair Masons/Arizona Ram Jack Case Study

CLIENT: 3D/I
ADDRESS: 2111 E. Highland, Ste 402B
Phoenix, AZ 85016
JOB LOC: Tempe Beach Stadium
LOC: Tempe, AZ

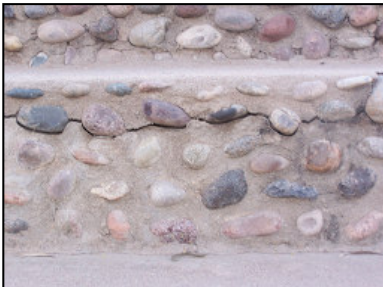
Pic #1 Before

The picture below shows typical cracks that occurred in the vertical risers of the bleacher seating.

Solutions to encountered problems: The Field Supervisor was fired, for other reasons as well, and the color mix was corrected for the rest of the project. Patches were re-made where the color was wrong, which proved satisfactory, but not as perfect as desired.

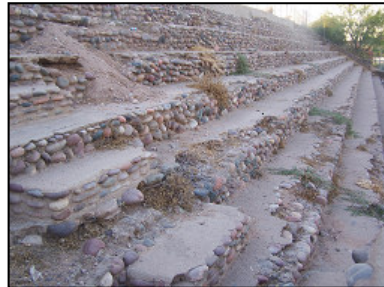
Pic #2 Before

In this picture, the severe deterioration of the cobblestone bleachers can be seen, in the north end of the stadium.

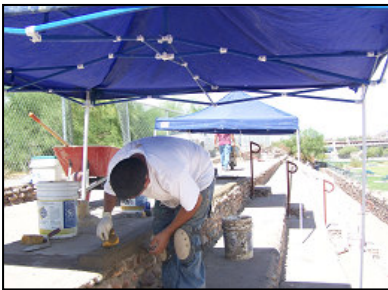
Pic #1 After

The above picture shows the south half of the stadium being worked on, overlooking the baseball field.

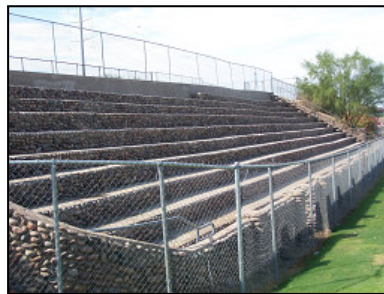
Pic #2 After

This picture shows the north portion of the stadium, overlooking the park.
