## INDUSTRY CASE STUDY

### Moman Residence—Scottsdale Grouting

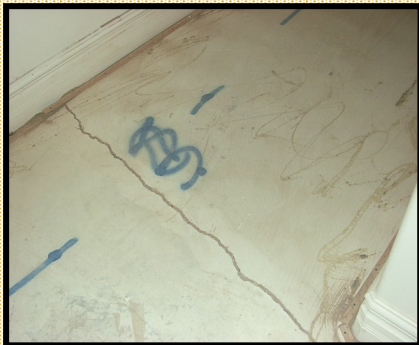
Crack in concrete slab

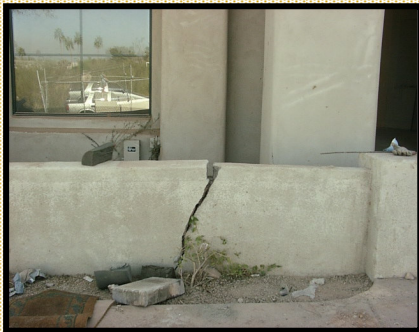
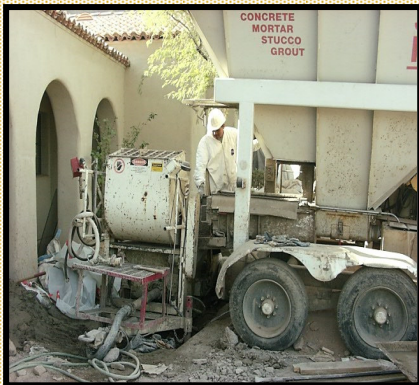
Grout being pumped under the house

Used low slump permeation grout. We predrilled using unique hydraulic drill with power sources out side the home. This enabled the use of a compact drill that could drill through the rocky sub soils and prepare the way for grout tubes. A grout wall was established on the west end of the house where it was strongly suspected subsurface water was coming from
