INDUSTRY CASE STUDY

Franklin Police and Fire High School Historic Renovation, Phoenix, AZ

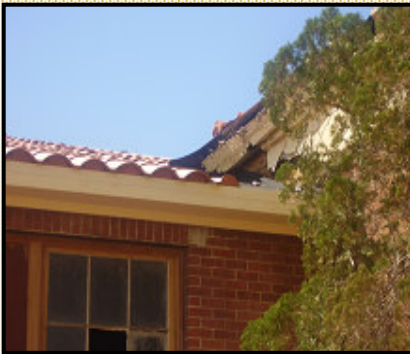
Severe masonry damage on the roof.

Solutions: Arizona Repair Masons used its Specialty division with extensive forensic expertise to provide all the floor repairs, the Concrete division to form and place new concrete work and the Masonry division to perform the tuck-pointing and masonry installations. Our other company Arizona Ram Jack underpinned the main entry with helical piers.

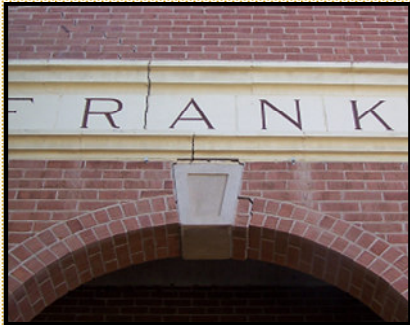
Archway keystone broken along stair-step crack from top of building.

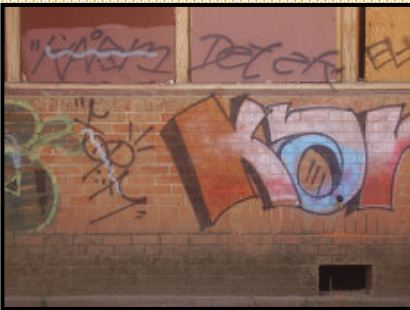
Complicating the tuck-pointing was graffiti on the north and east walls.

Challenges: A primary challenge was tuck-pointing to match the existing mortar color. After over 70 years, the mortar was stained brown, and the Historic Preservation division of the City of Phoenix wanted a color match. Pressure-washing of the brick surface would have damaged the mortar and necessitated tuck-pointing every joint of the exterior walls, outside the budget limitations of the project. Although extensive, spot tuck-pointing was necessary to blend in to the existing brickwork.

The challenge of matching the existing mortar color was achieved by mixing various mortar combinations and letting them cure for weeks before selecting the perfect match. Because the mortar stains were caused by the surrounding light brown soil, using some of the soil in the mixture was the secret to finding the right color match.
